**737-800 BCF**

**MAINTENANCE MANUAL,  
RIGID CARGO BARRIER –  
737-800 BCF**

**INCLUDING INSTRUCTIONS  
FOR CONTINUED  
AIRWORTHINESS**

**DOCUMENT: VA-AMM-1000**

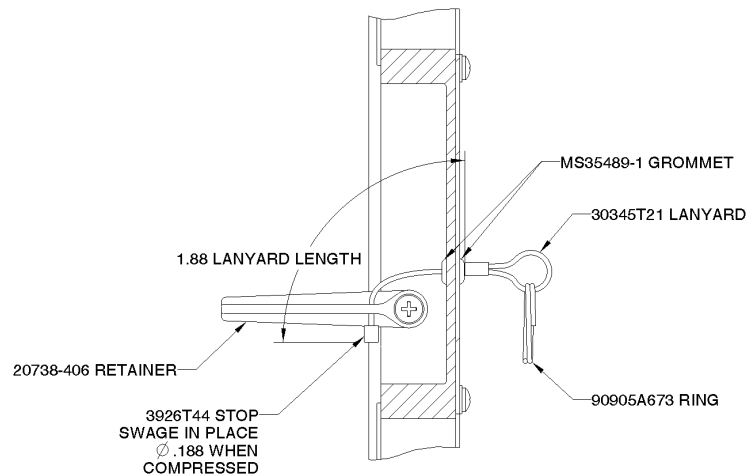
**TASK: DOOR LANYARD REPLACEMENT**

- (1) If required remove all loose components and replace as needed.
- (2) Replace quantity 2 MS35489-1 grommets by first cutting one flange off of each grommet. Install one each MS35489-1 grommets in the door, one on the forward side, one on the aft side. Bond in using 3145 RTV Silicone Adhesive. Allow to cure before replacing the lanyard.

- (3) Replace 30345T21 lanyard by cutting it to 1.88 in length from the eyelet. Feed through grommets in door and through the hole in 20738-406 retainer. Swage the

- (4) Install 90905A673 Ring on the end of the lanyard eyelet.
- (5) Verify operation of the lanyard by rotating the retainer down then pulling the lanyard to rotate the retainer up. The retainer must rotate  $90^\circ$  and engage the integral detents. If the latch does not rotate fully the lanyard must be replaced with a longer one.
