737-800 BCF

STRUCTURAL REPAIR MANUAL, RIGID CARGO BARRIER

DOCUMENT: VA-SRM-1000

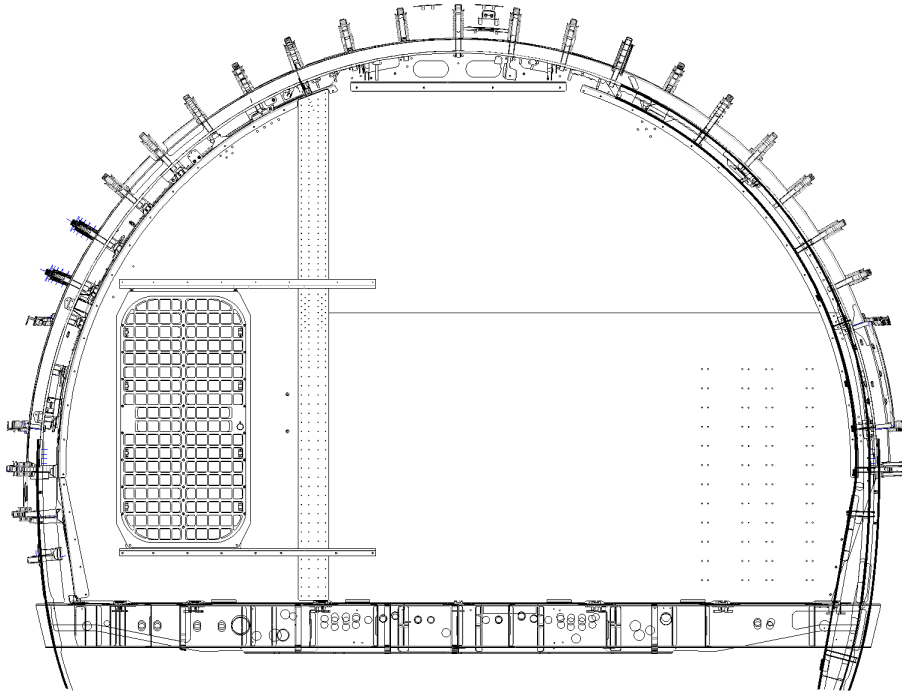
FIGURE 53-00-03-1: VIEW LOOKING FORWARD AT RCB

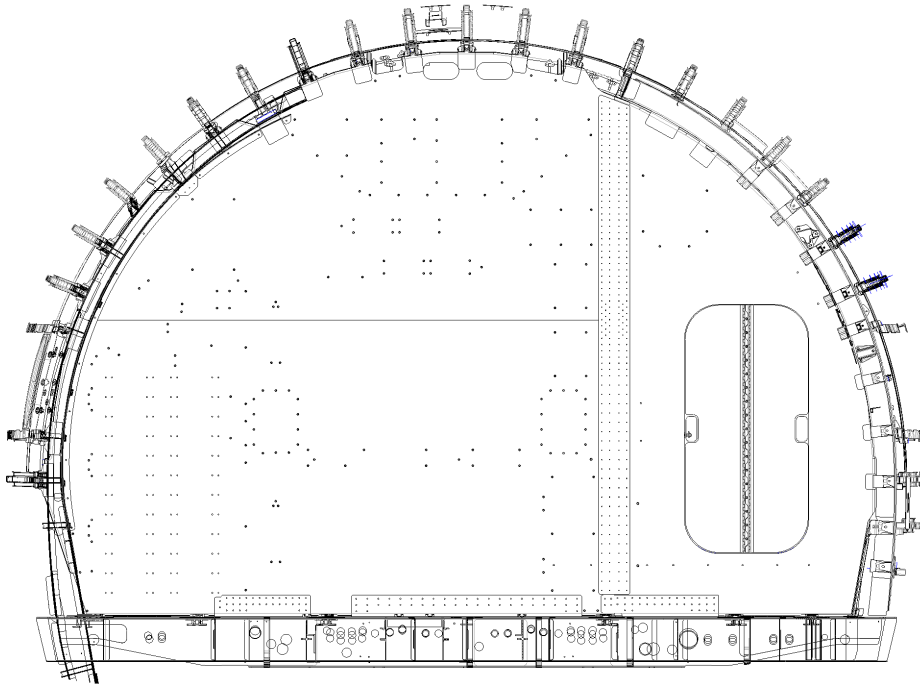
FIGURE 53-00-03-2: VIEW LOOKING AFT AT RCB

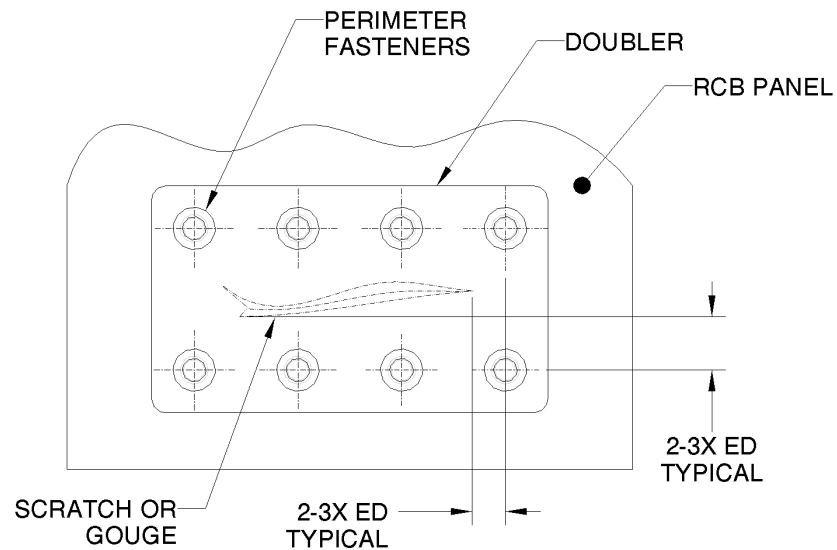
Install a .160 thick 7075-T6 Aluminum Doubler over the affected area in accordance with Figure 53-20-00-1 below. Remove all paint and clean the affected area of the scratch or gouge extending out at least 3.0 inches. Layout the Doubler shape by measuring 1.0 inch beyond the scratch or gouge. Allow for additional material for fasteners in accordance with notes in 53-30-00. After Doubler dimensions are determined and fastener holes are drilled,

de-burr the Doubler. Apply Hysol EA9394 between the Doubler and the Barrier Panel. Install using CR3523-5-() Cherrymax Rivets (grip will vary based on barrier face sheet thickness at specific location). Alternate, through bolt using: NAS6204-() Bolts, NAS1149F0463P Washers and MS21042L4 Nuts. Minimum quantity of 4 fasteners required. The fastener pitch is to be no greater than 1.5" spacing CL to CL. If the repair is restricted by adjacent components a unique repair is required, contact Ventura Aerospace, Inc. for engineering disposition.

Figure, 53-20-10-1, Major Scratch and Gouge Repair

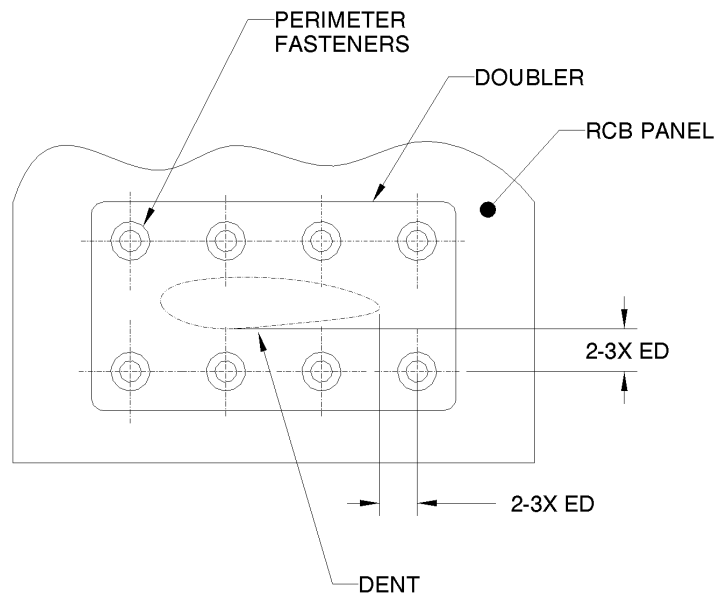
Install a .160 thick 7075-T6 Aluminum Doubler over the affected area in accordance with Figure 53-00-21-2 below. Remove all paint and clean the affected area of the dent extending out at least 3.0 inches. Layout the Doubler shape by measuring 1.0 inch beyond the dent. Allow for additional material for fasteners in accordance with notes in 53-30-00 REPAIR NOTES. After Doubler dimensions are determined and fastener holes are drilled, de-burr the Doubler. Apply Hysol EA9394 between the Doubler and the Barrier Panel. Install using CR3523-5-(XX) Cherrymax Rivets (grip will vary based on barrier face sheet thickness at specific location). Alternately, you may through bolt using: NAS6204-(84) Bolts, NAS1149F0463P Washers and MS21042L4 Nuts. Minimum quantity of 4 fasteners required. The fastener pitch is to be no greater than 1.5" spacing CL to CL. If the repair is restricted by adjacent components, a unique repair is required, contact Ventura Aerospace for engineering disposition. Dents greater than .10 deep and covering an area greater than 4.0 in² require the replacement of the RCB panel.

Figure, 53-20-10-2, Major Dent Repair

NOTE: DENTS IN EXCESS OF 3.00 INCHES IN ANY DIRECTION MUST HAVE AN FAA APPROVED REPAIR DEFINED SPECIFICALLY FOR THAT DAMAGE. CONTACT VENTURA AEROSPACE ENGINEERING FOR DISPOSITION.

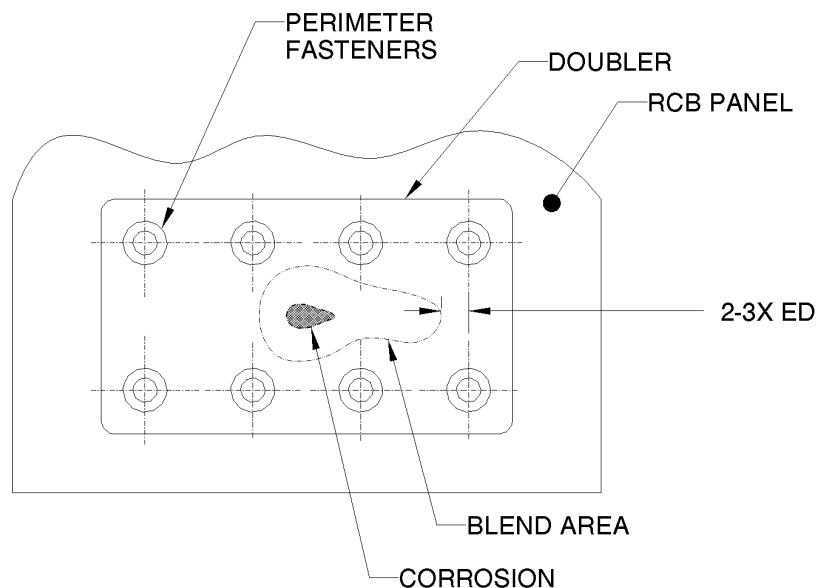
Install a .160 thick 7075-T6 Aluminum Doubler over the affected area in accordance with Figure 53-00-21-3 below. Remove all paint and clean the affected area of the corrosion extending out at least 3.0 inches. Layout the Doubler shape by measuring 1.0 inch beyond the corrosion. Allow for additional material for fasteners in accordance with notes in 53-30-00 REPAIR NOTES. After Doubler dimensions are determined and fastener holes are drilled, de-burr the Doubler. Apply Hysol EA9394 between the Doubler and the Barrier Panel. Install using CR3523-5-() Cherrymax Rivets (grip will vary based on barrier face sheet thickness at specific location). Alternately, you may through bolt using: NAS6204-() Bolts, NAS1149F0463P Washers and MS21042L4 Nuts. Minimum quantity of 4 fasteners required. The fastener pitch is to be no greater than 1.5" spacing CL to CL. If the repair is restricted by adjacent components, a unique repair is required, contact Ventura Aerospace for engineering disposition. Corrosion in the core material of the Main Barrier Panel is not repairable. If corrosion is found in the core material the panel must be replaced, as there is no practical means to repair the core material. Where corrosion extends deeper than the .040 with a total area exceeding 3.0 in² or covers a total area greater than 64 in² the Barrier Panel must be replaced.

Figure 53-20-10-3, Major Corrosion Repair

NOTE: CORROSION IN EXCESS OF 3.00 INCHES IN ANY DIRECTION MUST HAVE AN FAA APPROVED REPAIR DEFINED SPECIFICALLY FOR THAT DAMAGE. CONTACT VENTURA AEROSPACE ENGINEERING FOR DISPOSITION.
